Integral Energy Sub Station - Carlingford

Project: Transformer Bund Areas

Category: Secondary Containment

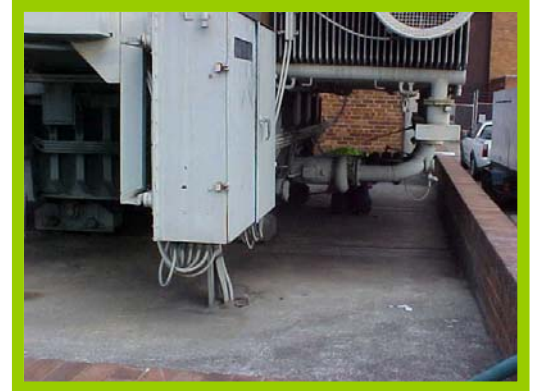
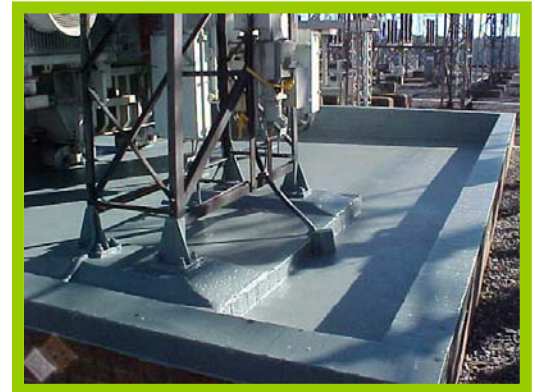
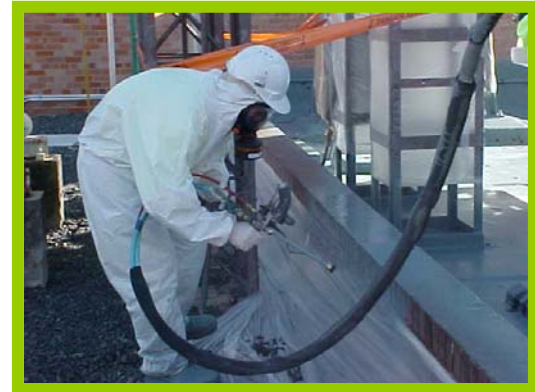
Before...

Four transformers at an Integral Energy Sub Station showed oil contamination problems. The transformers were leaking onto and through the concrete bund substrate.

To rectify this bund, the concrete was high pressure/hot water cleaned and then brick walls 'bagged' with a screed material. Rhino Linings Duraspray was then applied to the walls and floor to form a fully seamless area. A 24 grit aggregate was also added to the traffic areas to reduce 'slip' situations.
