Fisherman's Table – Internal Guttering

Project: Incorrect Guttering Fitments

Category: Water Seepage

Date: October 2005

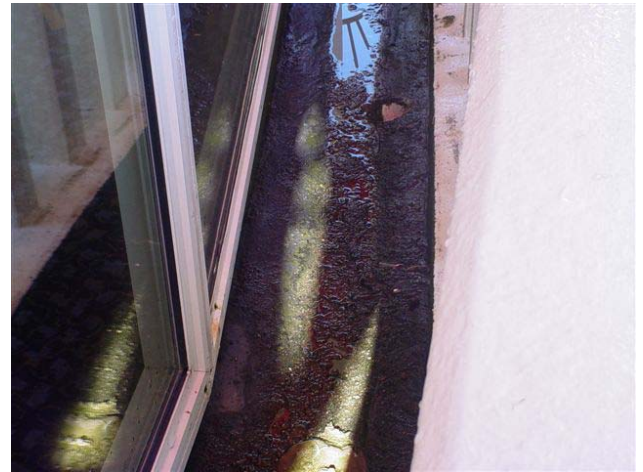
Before...

This guttering system had been designed incorrectly with water running away from drainage points and pooling where it shouldn't. This left water to seep into the building. The gutters were reformed and the flow adjusted then coated with TUFF STUFF to eliminate the incorrect flow.
