Energy Sub Station Bund

Project: Integral Energy Substation

Category: Secondary Containment

Product: Rhino Linings Tuff Stuff

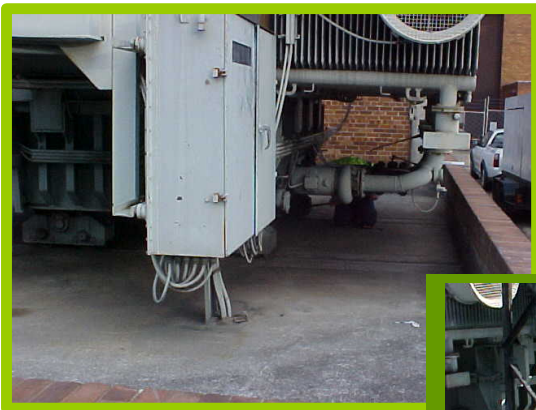
Before

Four transformers at the Integral Energy Sub Station were experiencing oil containment problems. The transformers were leaking oil onto and through the concrete, leaching into the ground below.

After having the concrete cleaned, and the brick walls bagged, Rhino Linings Duraspray was applied to the walls and floors to form a fully contained bed area. 24 grit aggregate was also added to the traffic areas addressing OH&S requirements.
