Water Tank

Project: Tank

System: Rhino Linings TUFF STUFF

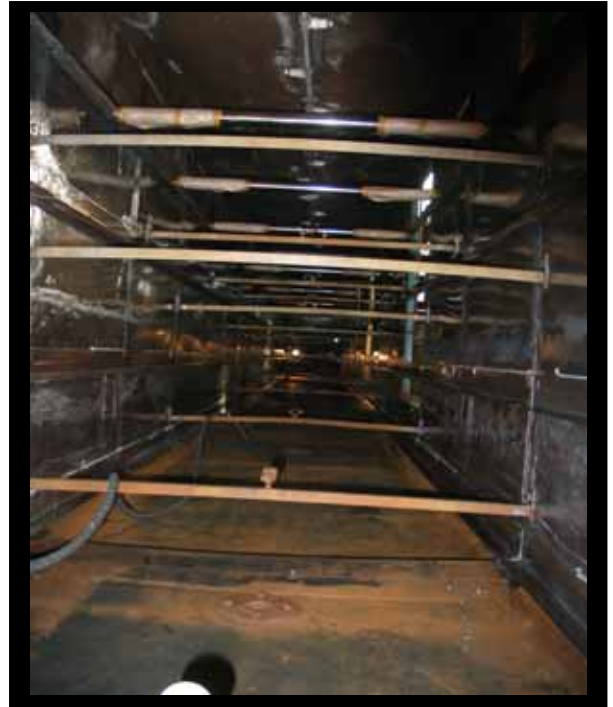
Before...

This 40 metre long tank was suspended 3 meters above a workshop floor containing various electronic machinery and motors. Major problems occurred due to the tank leaking water onto the motors below causing them to blow up, this would shut the whole plant down until the motors were repaired..

Both the walls and floor of the tank were lined with TUFF STUFF. It was then water tested and had no leaks.
